Sports Bucket Seat (I-no. 388/389)

Vehicle Type: **Cayman (987)/Cayman S (987)**

Model Year: **As of 2006**

Information: **Retrofitting**

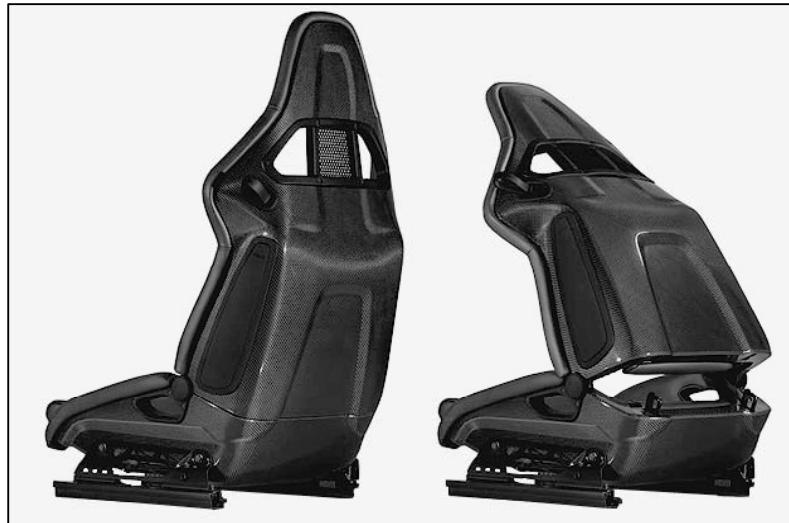
Notes: The sports bucket seat with integrated thorax airbag was developed and approved for use on public roads and for racing events (Club Sport, only in combination with flame-retardant fabric cover). Pulling a loop on the backrest will release it and fold it forwards.
