**Sport Bucket Seat (I-no. 388/389)**

Vehicle Type: **911 Carrera (997) / 911 Turbo (997)**

Information: **Retrofitting**

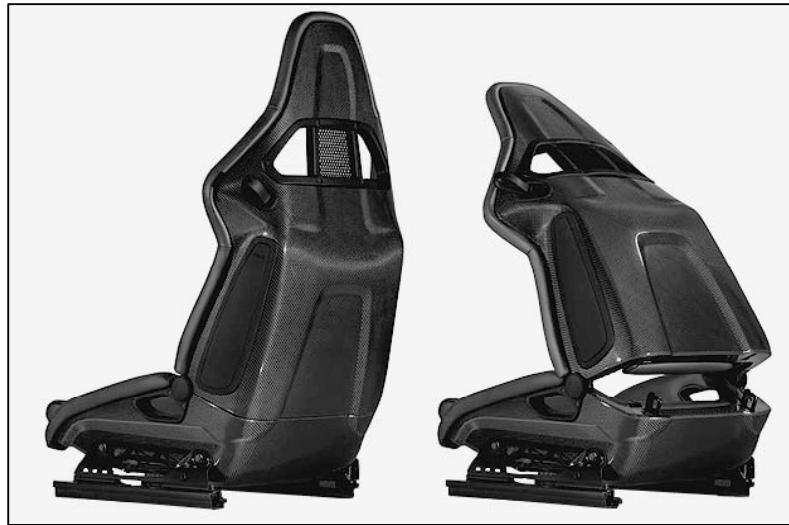
Notes: The sports bucket seat with integrated thorax airbag was developed and approved for use on public roads and for racing events (Club Sport, only in combination with flame-retardant fabric cover). Pulling a loop on the backrest will release it and fold it forwards.

Seats can be retrofitted separately or as a pair (driver's and passenger's side).

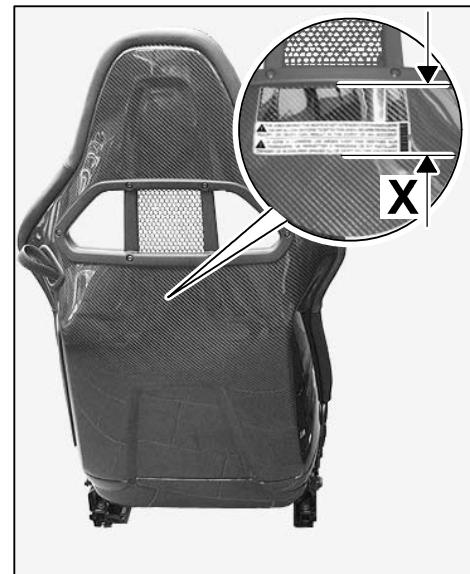
Figure 2

2 **ONLY** for vehicles without rear seats for USA / Canada:  
Affix warning label (sticker) to the rear of the backrest.

- 2.1 Clean bonding area (⇒ *Figure 2 -cut-out-*) to remove any dust and grease.
- 2.2 Mark measurement X (⇒ *Figure 2 -cut-out-*) approx. 75 mm as shown in ⇒ *Figure 2* on the rear of the backrest.

- 2.3 Affix sticker in relevant position.
- 3 Install sports bucket seat ⇒ *Workshop Manual '720119 Removing and installing folding sports bucket seat - section on "Installing"*.

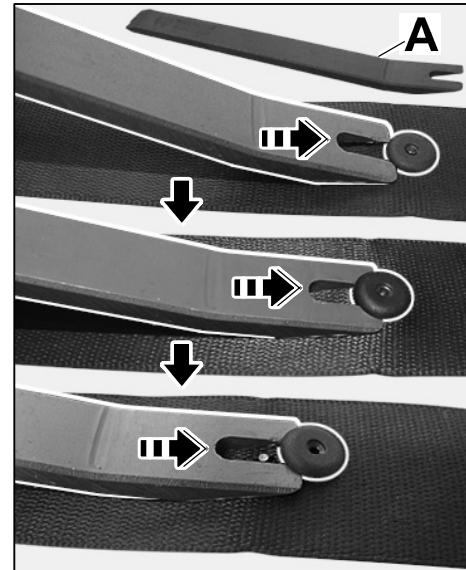
- 6.1 Carefully insert a plastic spatula, e.g. from Wieländer + Schill (article no. 0704  $\Rightarrow$  Figure 3 -A-), between the bottom part of the plastic rivet and the belt strap.

- 6.2 Carefully press plastic spatula along the belt until the bottom part of the plastic rivet springs off upwards ( $\Rightarrow$  Figure 3).
- 6.3 Remove top part of plastic rivet out of the belt strap.

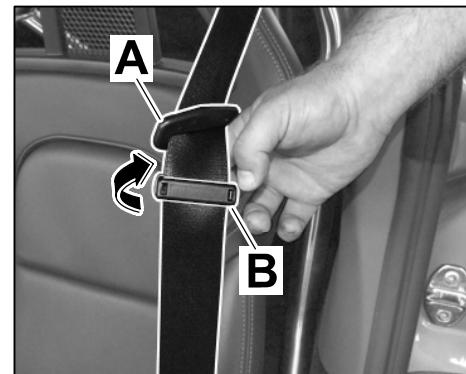
- 6.5.2 If belt strap is not damaged:  
Hold belt tongue ( $\Rightarrow$  Figure 4 -A-) in former position of plastic rivet and place clamping piece ( $\Rightarrow$  Figure 4 -B-) approx. 10 cm below this on the belt strap, fold it over ( $\Rightarrow$  Figure 4 -arrow-) and clip it in.
